PHOTOGRAPHIC SURVEY OF THE LDEF MISSION

NASA Special Publication 531

Robert L. O'Neal

Langley Research Center
Hampton, Virginia 23681-0001

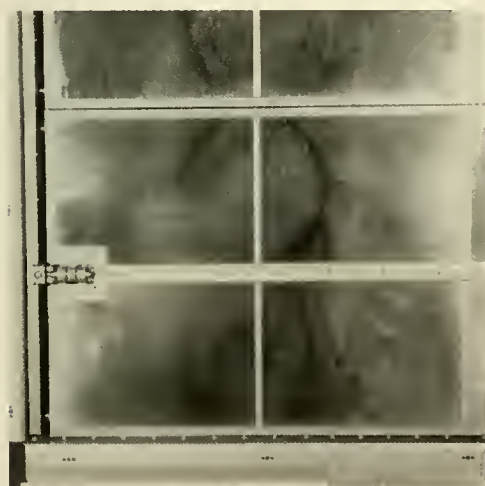
Figure 87
Photo No.: KSC-390C-1765.02
Dup. Neg. No.: L91-7557
LISAR No.: EL-1994-00249
Photo Credit: KSC
Photo Date: 3/9/90
Location: KSC SAEF II
Subject: Postflight Detail of Lower Left of Tray A3

Figure 87 (Postflight). This photograph of the lower left one-fourth of the tray shows light and room reflections in the highly reflective gold foil. The foil appears to be in preflight condition.

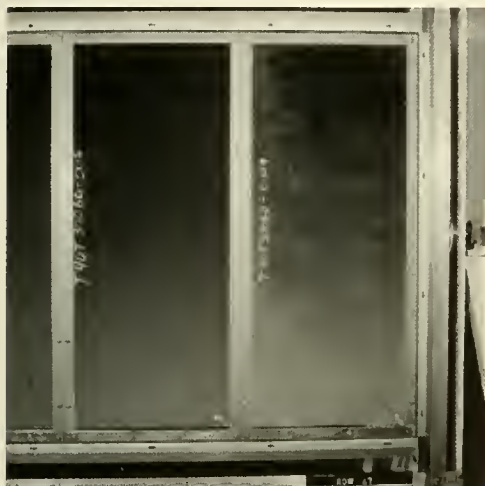
Figure 108
Photo No. KSC-390C-2145.11
Dup. Neg. No.: L91-7660
LISAR No.: EL-1994-00504
Photo Credit: KSC
Photo Date: 3/21/90
Location: KSC SAEF II
Subject: Postflight Detail of Tray A7

Figure 108 (Postflight). This close-up is of panels F-178/T300 cocured and PMR-15. The yellow identification numbers appear lighter. The fine horizontal lines, cracks, and crazing are still visible on the surface of each panel. The F-178/T300 cocured panel seems to have changed from the light gray in the in-flight photograph to a brownish gray. The geometric pattern visible on the PMR-15 panel in flight is not visible in this photograph. A gray haze or dust appears to cover the gray brown panel surface. Scratch marks and abrasions on the lower left edge of the panel were on preflight photographs.

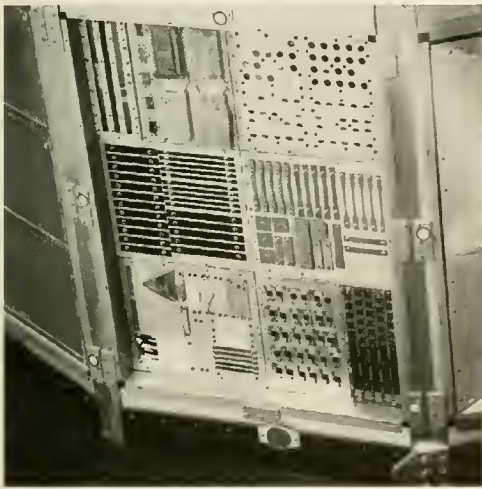
Figure 111
 Photo No.: S32-76-027
 Dup. Neg. No.: L90-10381
 LISAR No.: EL-1994-00666
 Photo Credit: JSC
 Photo Date: 1/12/90
 Location: In Flight
 Subject: In-Flight Survey of Tray A8

Figure 111 (In Flight). Plate I, in the upper left, is shown with two of the four solar arrays missing and one solar cell appears to be attached at only one corner. Other components seem to be secure. The composites on Plate II in the left center appear to have no physical damage. On Plate III, in the lower left corner of the tray, the thin films without protective coatings on the lower left corner of the plate sustained significant damage or were destroyed. The metallized film apparently survived with minimum damage. On Plate IV, in the upper right corner, several of the coatings appear to have changed to a darker color and a light brown discoloration shows around the outer edges of the mounting plate and along the right edge of the coverplates. On Plate V, in the right center, all specimens, including the tape holding down the small specimen in the lower right corner, have darkened significantly during the extended time in space. On Plate VI, in the lower right corner, the solar cell components appear to have no physical damage. The colors of the test specimens, however, seem to have darkened.

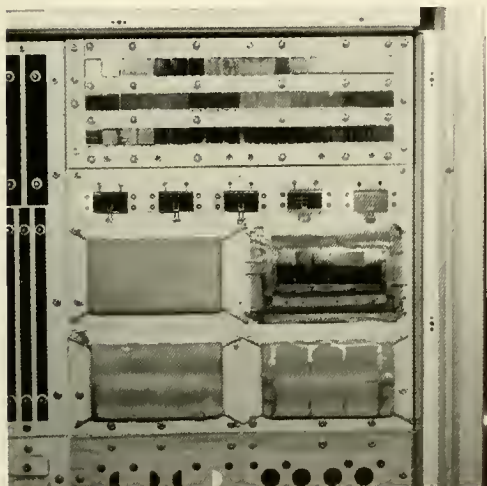
Figure 115 (Postflight). On Plate I, in the upper right corner, three of the four solar arrays are missing. One apparently was the one flying free near the LDEF just prior to retrieval. (See fig. 21.) Another was found in the Space Shuttle bay after the LDEF removal. Other components appear to be secure.

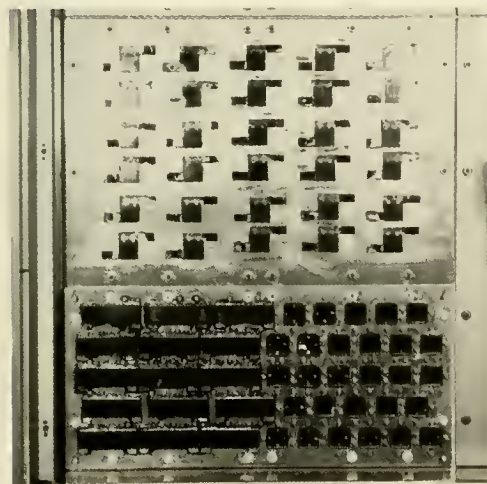
Figure 116 (Postflight). This close-up photograph of Plate VI in the lower left one-sixth of the tray shows that the solar cell components appear to be without physical damage. The colors of the specimens seem to have darkened.

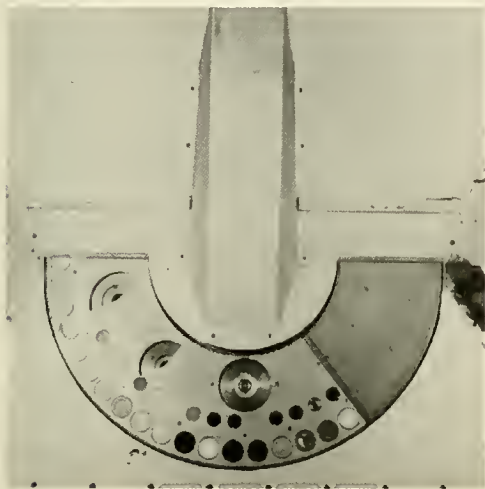
Figure 122
Photo No.: KSC-390C-1419.03
Dup. Neg. No.: L91-7715
LISAR No.: EL-1994-00375
Photo Credit: KSC
Photo Date: 2/28/90
Location: KSC SAEF II
Subject: Postflight Detail of Tray A9

Figure 122 (Postflight). This close-up photograph is of the carousel and test specimens. Note the discoloration streaks on the silvered Teflon film in the upper portions of the photograph and the evidence of numerous small impact discolorations. While changes in color have occurred in both the active and passive test samples, they appear to be the same as in flight. The three radiometers seem to be without physical damage.

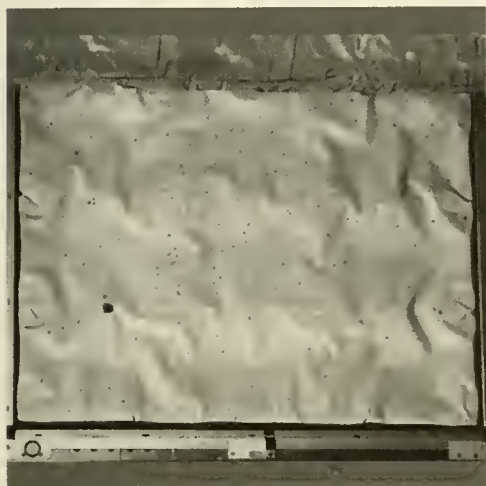
Figure 128
Photo No.: KSC-390C-612.01
Dup. Neg.: L92-17792
LISAR No.: EL-1994-00122
Photo Credit: KSC
Photo Date: 1/30/90
Location: KSC OPF
Subject: Postflight Survey of Tray A10

Figure 128 (Postflight). The thermal cover surface appears to have changed from specular to opaque (glossy white) with many black dots of various sizes. These black dots are probably the results of impacts or penetrations of the 5-mil Teflon film that allowed atomic oxygen to oxidize and erode the layer of vapor-deposited silver beneath. The cover is not as taut as in the in-flight photograph and locations of Velcro attachment pads are not as prominent. The ground strap appears to be in place and to have no visible damage, but it appears to be a deeper copper color. The cradled RMS arm is visible at the upper edge of the photograph.

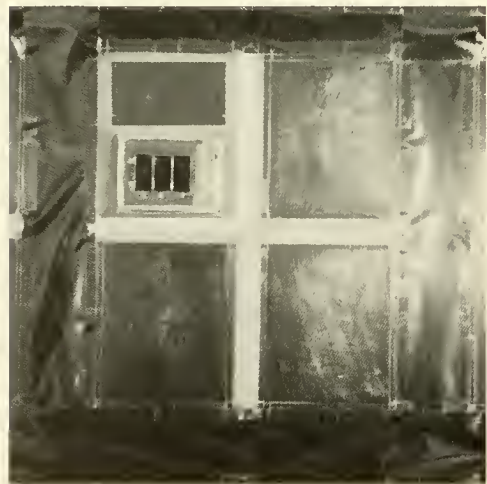
Figure 162 (Postflight). This photograph of the upper center one-sixth of the tray shows that the experiment has no apparent physical damage. Surfaces remain highly reflective. The white paint around the outer edges of the solar cell modules appears to have changed to a light tan.

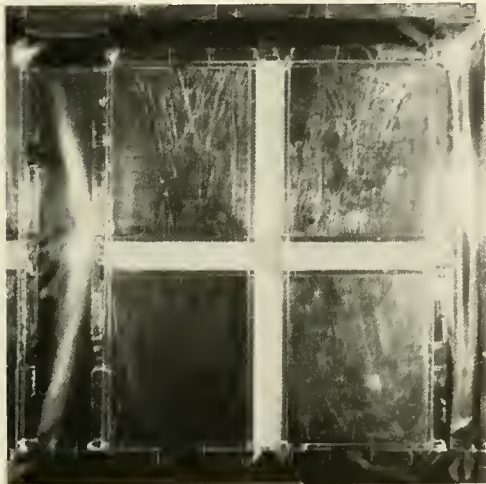
Figure 163 (Postflight). This photograph is of the upper right one-sixth of the tray. It shows the experiment with no apparent physical damage. Surfaces remain highly reflective.
